# Road-Stream Crossing Inventory Report: Buffalo County, Wisconsin

Sara Strassman, Ernie Ludke, Maggie Dremsa

Trout Unlimited, Driftless Area Program, La Crosse, Wisconsin

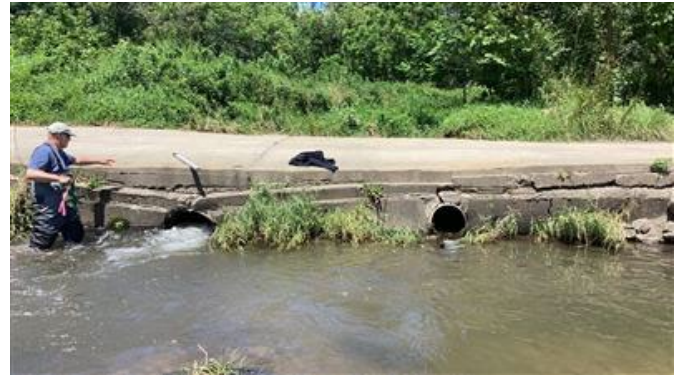
Figure 11: Outlet image

Site notes: Two 19 foot-long, 1.8ft by 2.0ft and 1.3ft by 1.3ft metal culverts with a 0.3 ft perch height that impedes aquatic passage. These culverts are also very undersized, constricting water flow which increases water velocities.

| Crossing Name;<br>Site ID | Fish<br>Passability | Site Condition/Notes | Full<br>Report |
|---|---|---|---|
| Eagle Creek at<br>Unnamed Road;<br>4317-8 | Barrier | Major deterioration; undersized double<br>culvert with concrete headwall/deck<br>slab that is cracking | <a href="#">Link to<br/>report</a> |

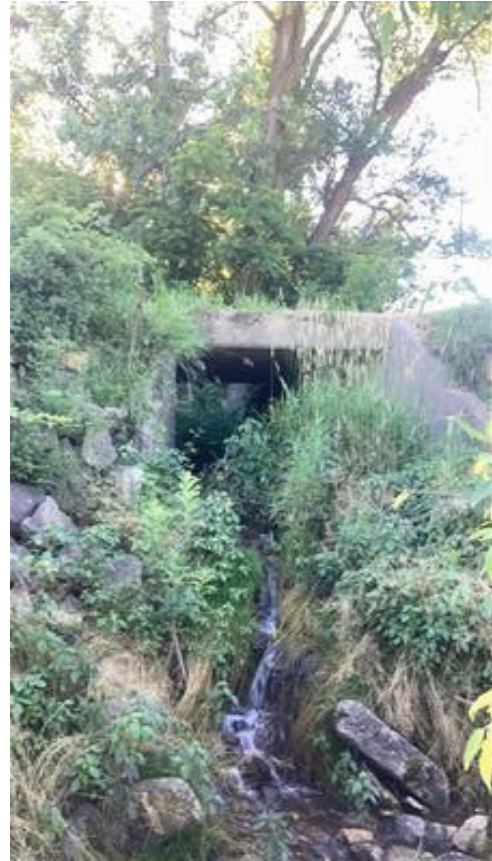
*Figure 13: Outlet image*

Site notes: An 18-foot long, 8ft by 8ft concrete box culvert with a large 4.0ft perch that impedes aquatic organism passage.

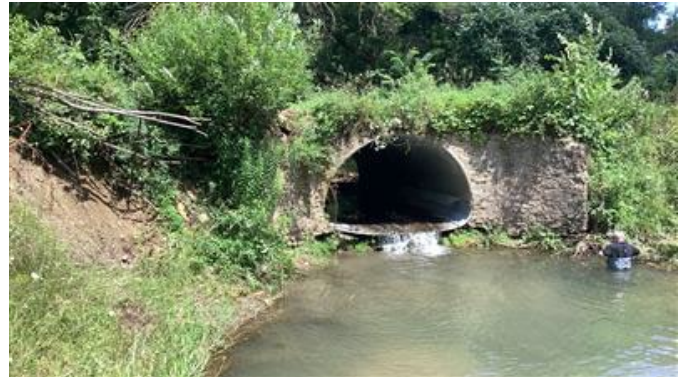
Figure 15: Outlet image

Site Notes: A 31-foot long, 11.5ft by 7.0ft pipe arch metal culvert. The culvert has a 1.0ft perch that freefalls into a large 3.5ft deep scour pool.

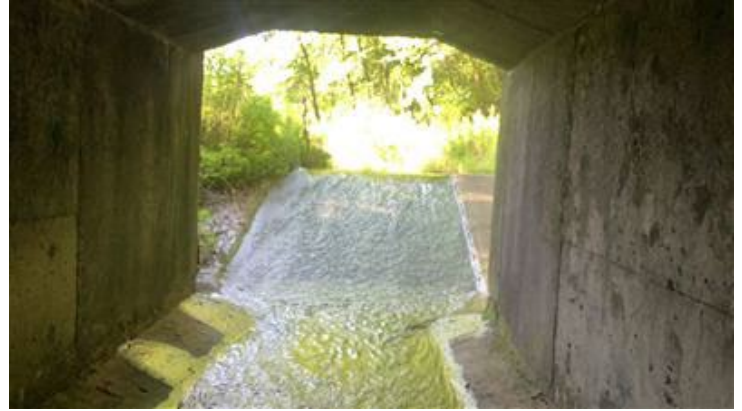
Figure 17: Inlet image

Site notes: A 195-foot long, 12ft by 10ft concrete box culvert. The upstream concrete apron is slanted disconnecting the stream which is creating upstream ponding. Aquatic organisms cannot pass through the culvert due to the upstream apron as well as the lack of substrate and water levels in the culvert.

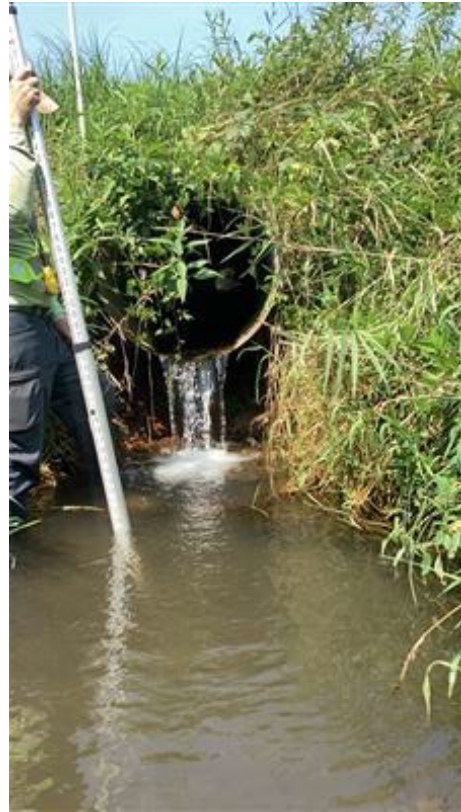
*Figure 19: Outlet image*

Site notes: A 55 foot-long, 2.5ft by 2.5ft metal culvert with a 2.0ft perch height and 2ft deep scour pool at the outlet.
