# Road-Stream Crossing Inventory Report: Buffalo County, Wisconsin

Sara Strassman, Ernie Ludke, Maggie Dremsa

Trout Unlimited, Driftless Area Program, La Crosse, Wisconsin

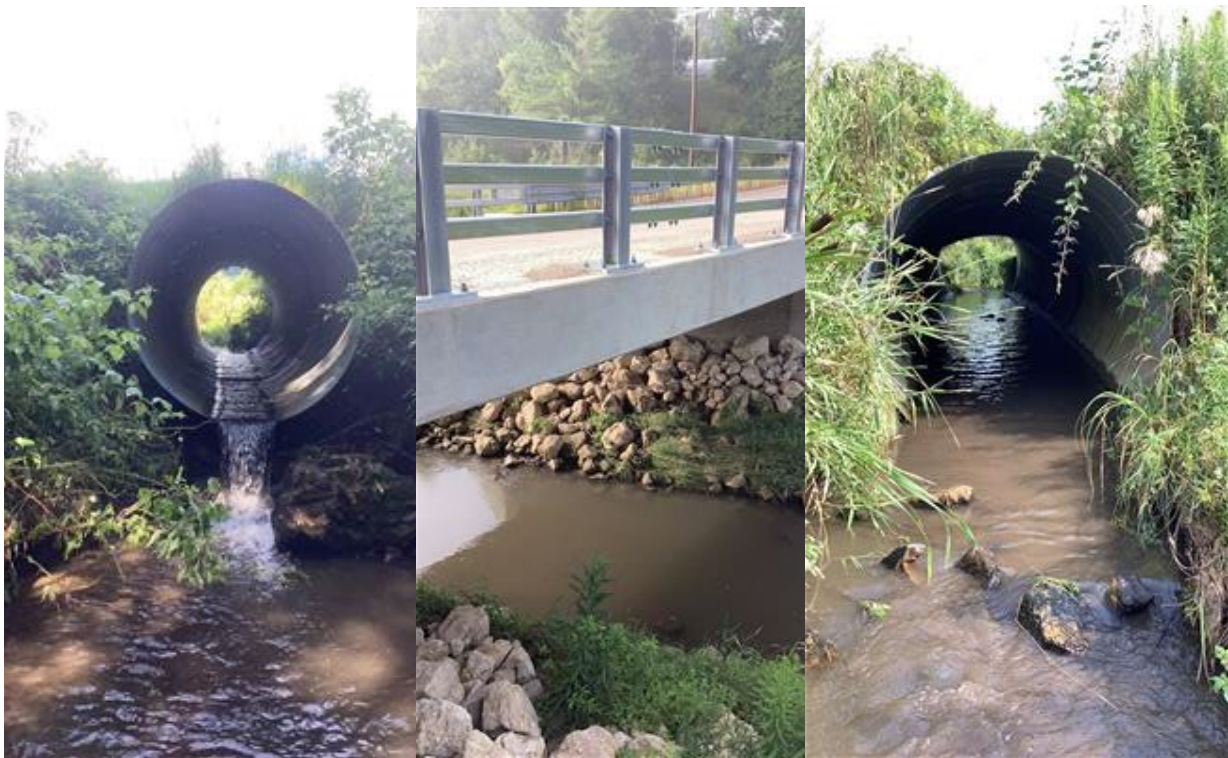
Photos: Left- Unnamed Stream at Ziegeweid Valley Rd, Middle- Eagle Creek at Co Rd G, Right- Doelle Creek at John Deere Rd
